BULGARIAN FIGHTER COLOURS 1919–1948

Vol. 1

Rainbow No 9136

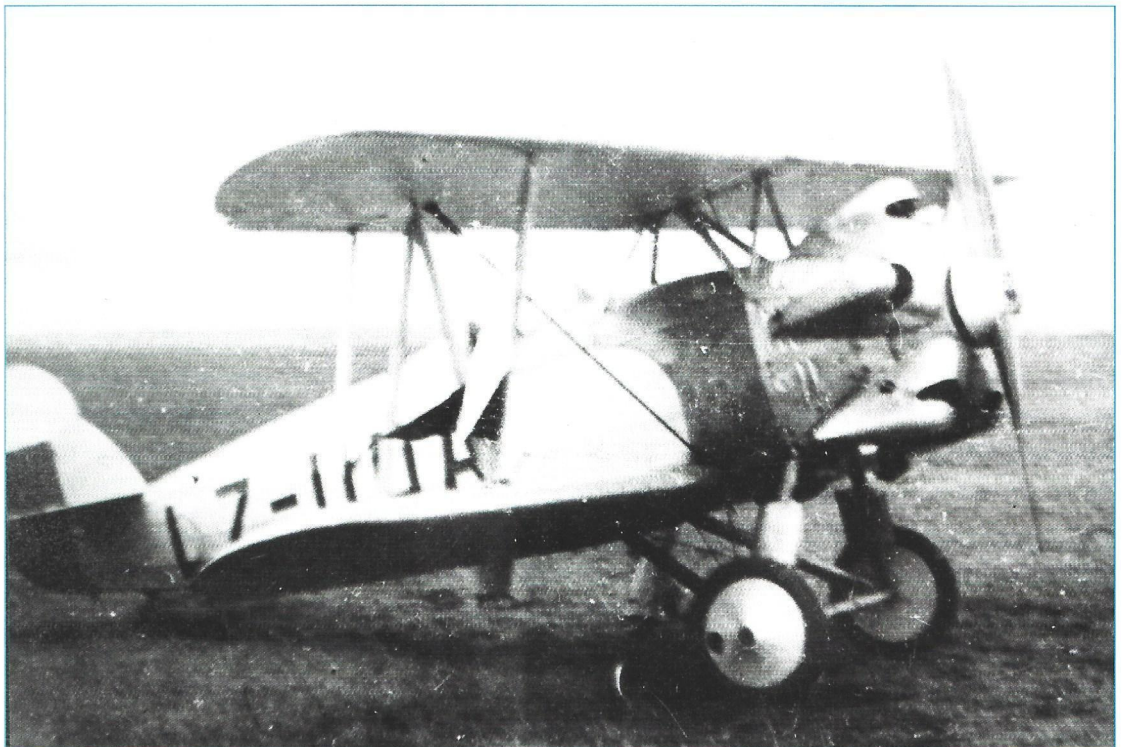
The DAR-5 prototype parked on Bozhurishte airfield in 1938, prepared for an exhibition flight (hence the Bulgarian flag attached to its wing struts). This time, the aircraft is fitted with the metal engine fairing covering the G&R 5 Titan radial engine. The propeller is made of wood, covered by a layer of transparent lacquer.

in service by personnel of Bozhurishte airfield. From 1932, it was re-registered LZ-UDA. Later during service, the prototype's radial engine was enclosed in a special sheet metal cowl, designed by Dipl. Eng. Kiril Yakimov Petkov³, finished in an eye-catching 'polished metal' look.

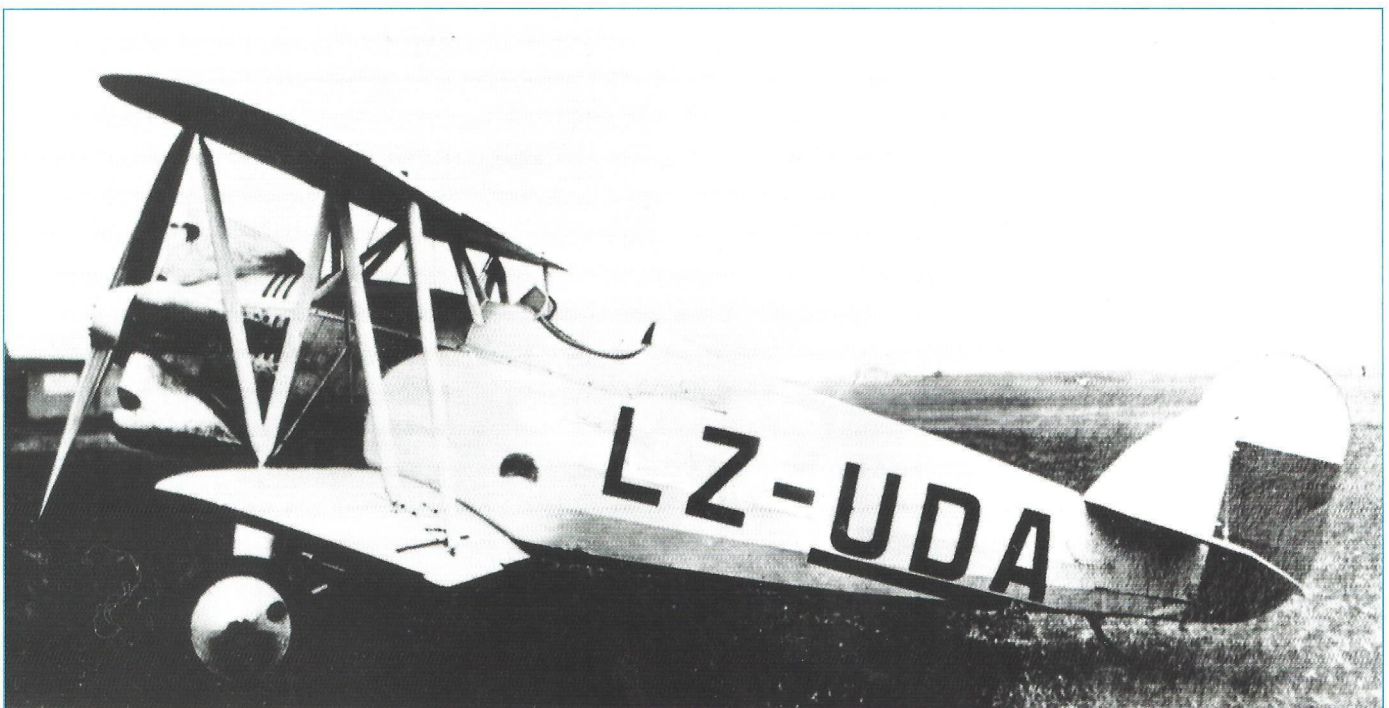
Side view of the aircraft. A lacquered wooden propeller is attached to the engine shaft.

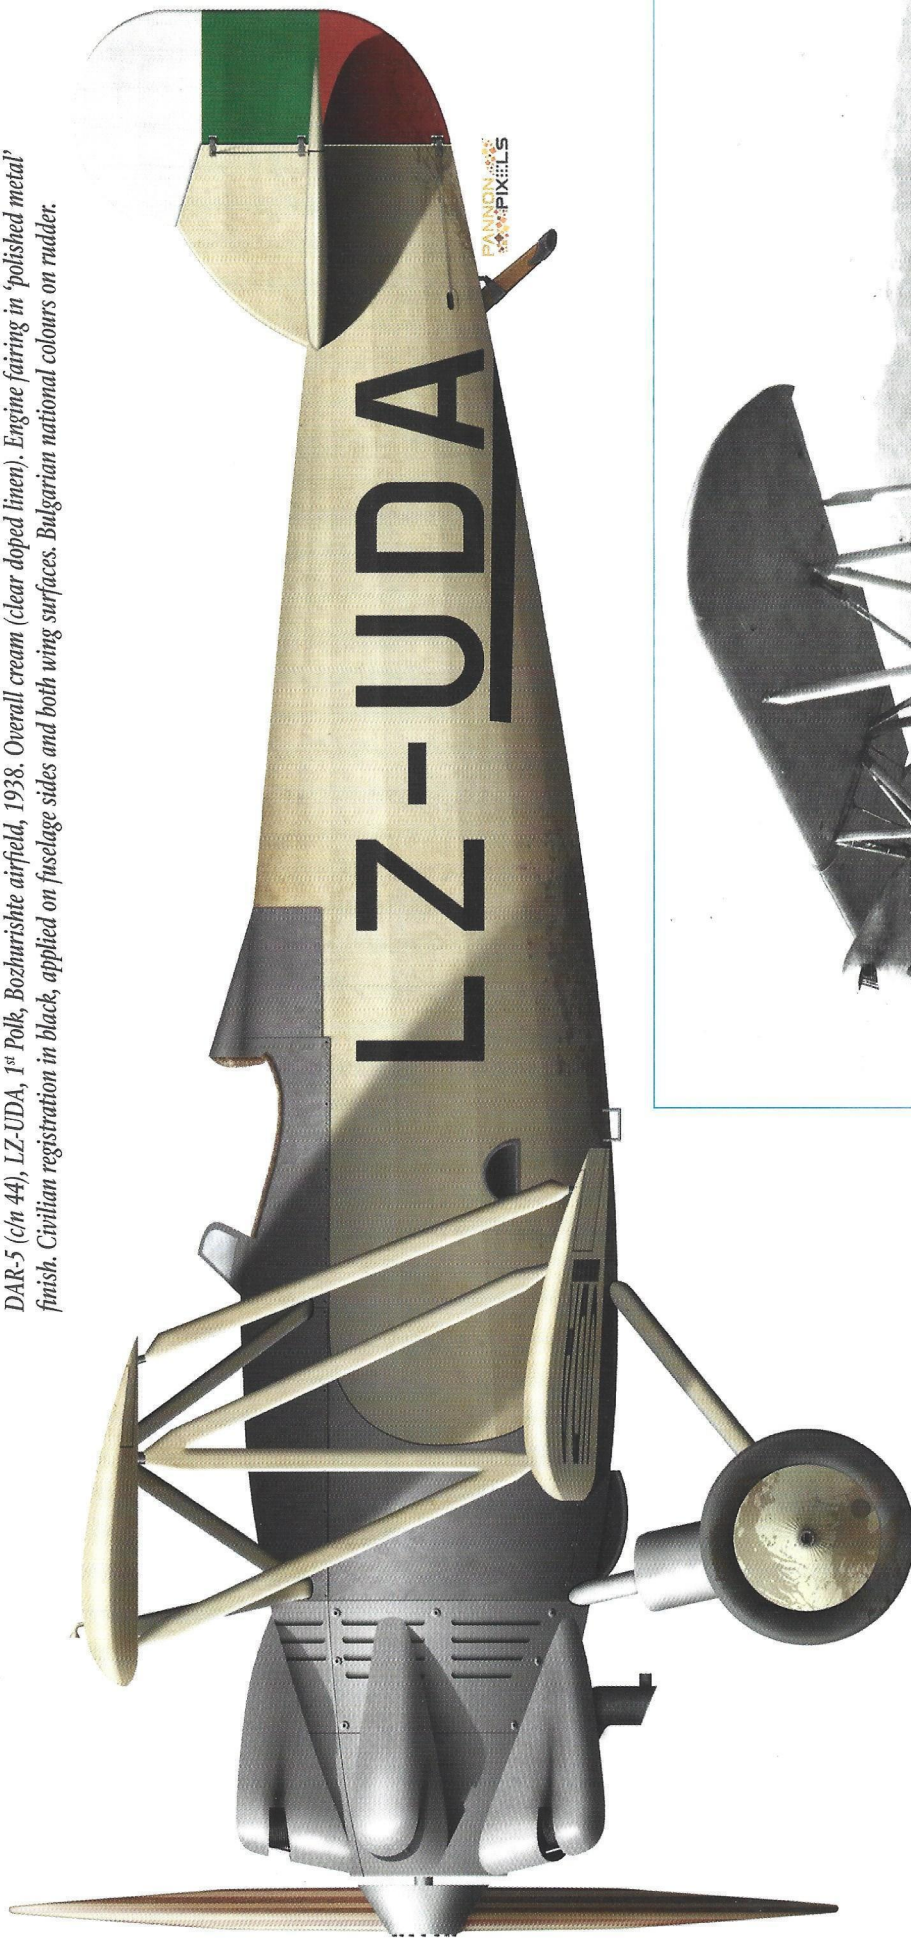
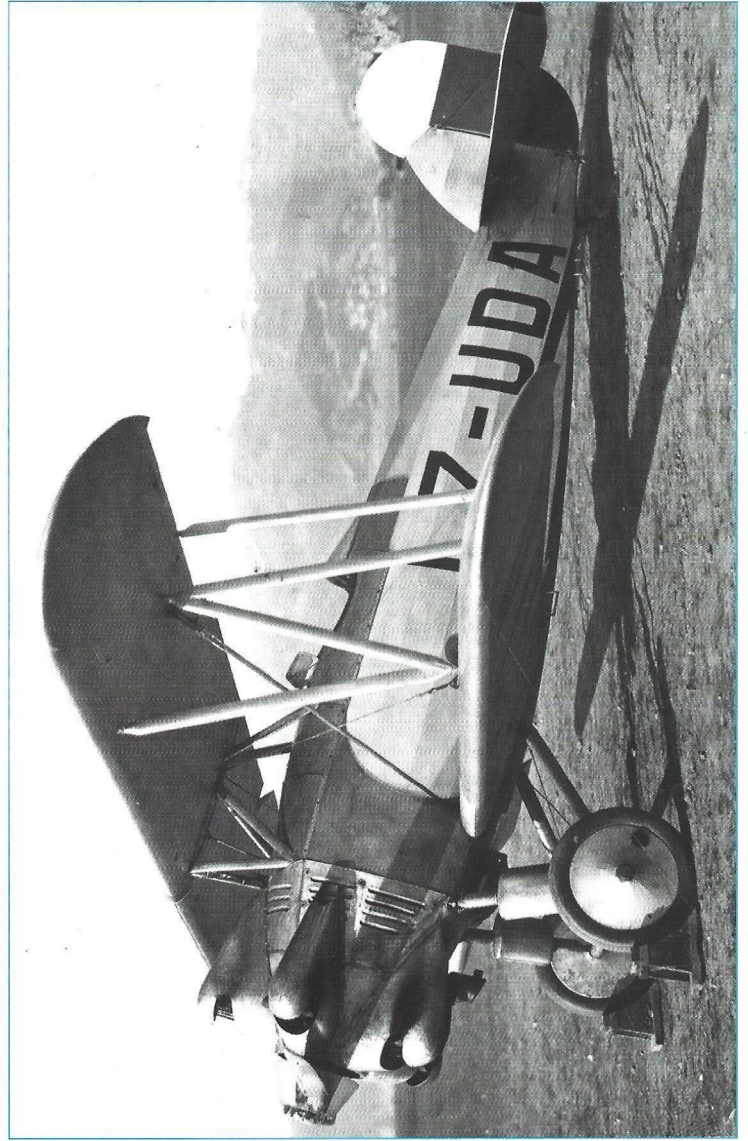
DAR-5 (c/n 44), LZ-UDA, 1st Polk, Bozhurishite airfield, 1938. Overall cream (clear doped linen). Engine fairing in 'polished metal' finish. Civilian registration in black, applied on fuselage sides and both wing surfaces. Bulgarian national colours on rudder.

The prototype received civilian registration, B-BUDA. It was applied in black, on the fuselage sides and both wing surfaces. The last four letters were underlined, as per official regulations. From 1932, the registration changed to LZ-UDA, as depicted. The Bulgarian tricolour was applied on the rudder, in horizontal stripes.

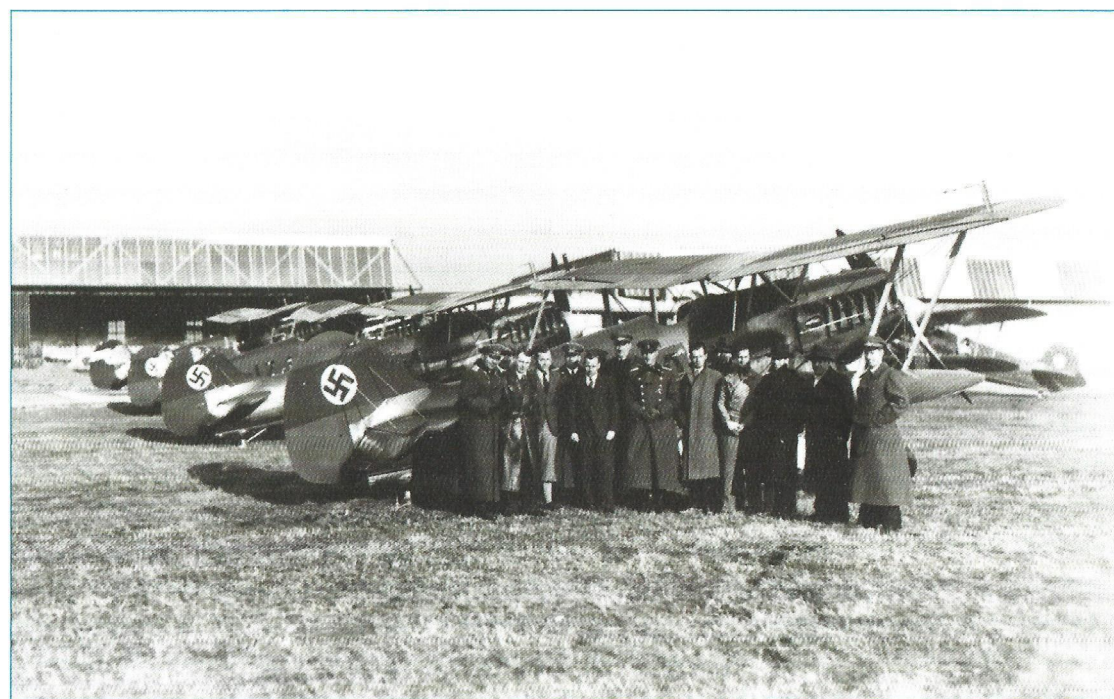
Five He 51Cs depicted on 'Sofia' (probably Bozhurishte) airfield shortly after their arrival in late December 1936. One of the German ferry pilots, Plewig, was the third man from left. The aircraft were painted in Dark Green camouflage colour on the fuselage and upper wing surfaces, and carry civilian ferry registration in black. Only the last letter of this registration is legible on the first (A), second (V) and last aircraft (M), while the third aircraft shows the full registration except for the last letter (D-IZJ_). The washable black paint the registration was applied on the fuselage has already begun to chip off.

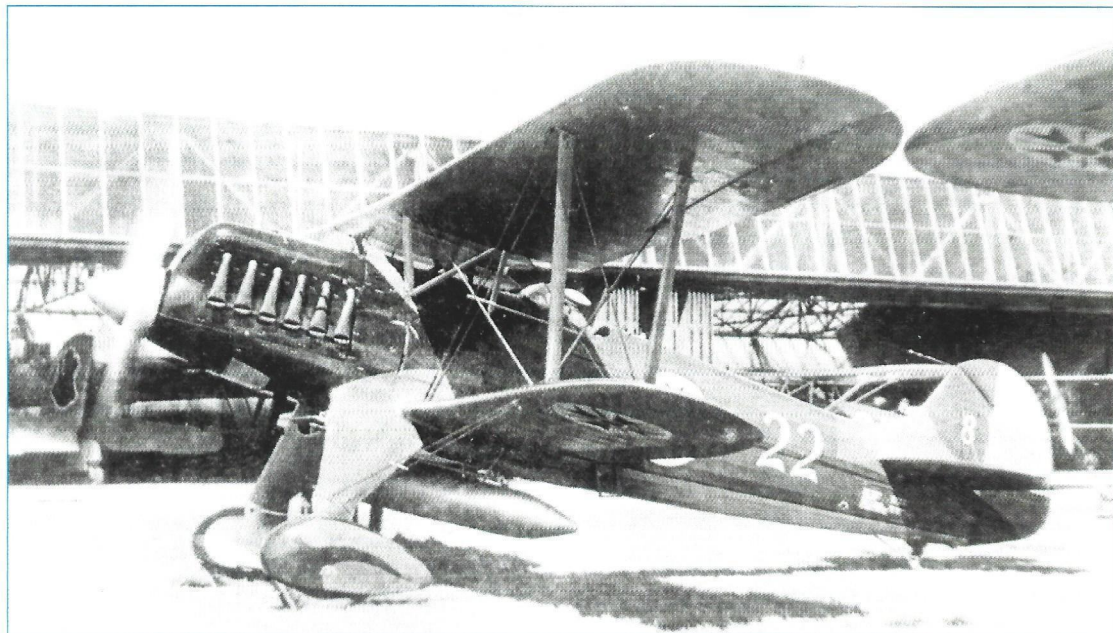
Once the He 51s were officially taken over by the Bulgarian air force in early 1937, they received full VNVV military markings (in six positions) and identification numbers (on the rear fuselage and the fin). The rudder was painted in Bulgaria's national colours of White, Green and Red. Depicted is 22-8 at Bozhur-ishte, the main air base of the VNVV sometime in 1937.

In combat service, the Heinkel He 51Cs received the newly introduced roundel-style air force marking (the so-called 'Tsarist roundel'), and were identified by two white numbers, one applied on the rear fuselage (believed to be the *krilo* number) and the other one on the fin (believed to be the aircraft's individual number within the *krilo*). Sometime in mid-1940 this numbering system was abandoned and

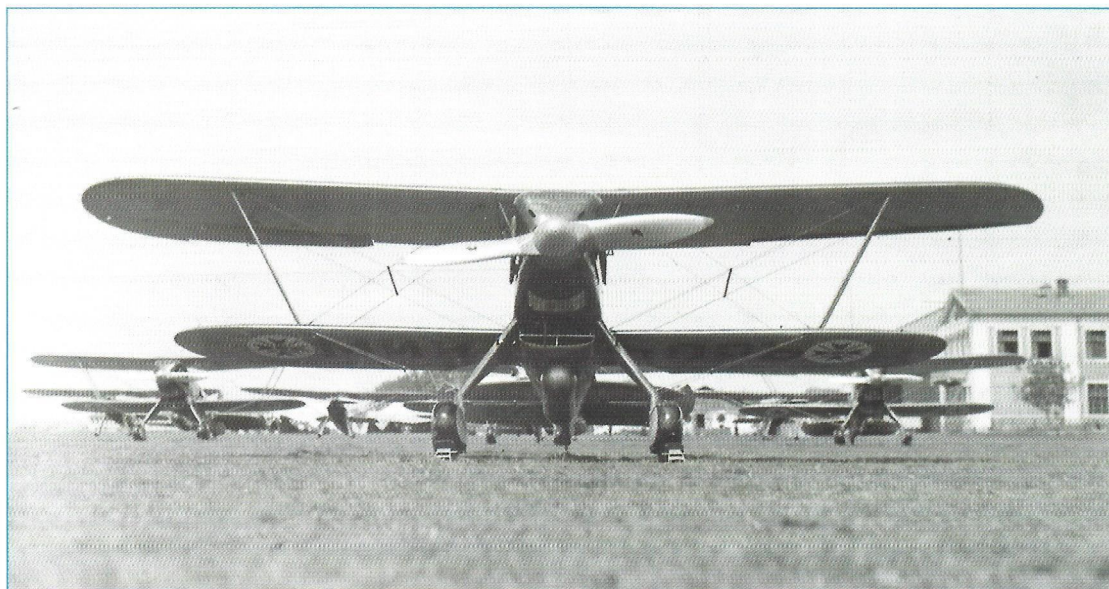
One of the He 51s purchased from Germany was reportedly paid for by the coal miners of the town of Pernik. To honour the financial effort of the miners, the word "Min'or" (Miner) was painted on the under surface of the lower wing in large, black capital letters (мин to the starboard and морЪ to the port wing under surface), as depicted on this head-on photo. Reportedly, the aircraft was presented to the miners and locals by Tsar Boris himself on 24 May 1937, although it must have been a fly-by only as the town does not have an airfield.

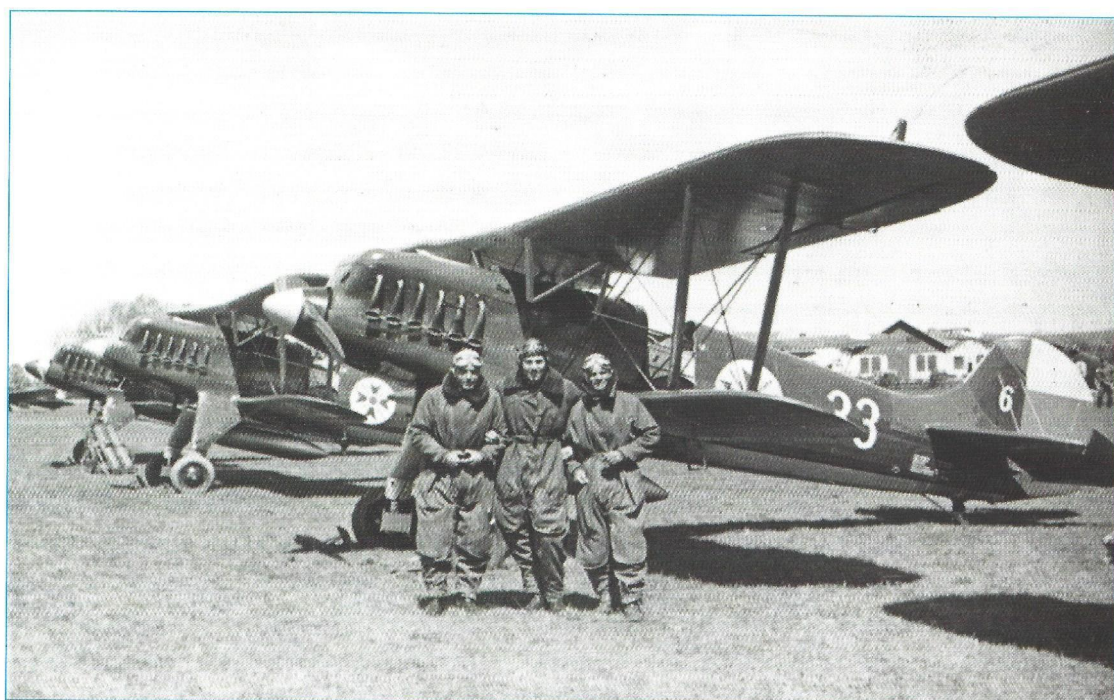
Another, albeit shorter, line-up of Sokols, featuring three pilot buddies posing for eternity (the middle one is Poruchik Lyuben Kondakov). Notice the inverted colour spinner attached to the first and last Sokol. The latter fighter does not have the customary underbelly auxiliary fuel tank attached. The wheel spats had been removed for easier service.

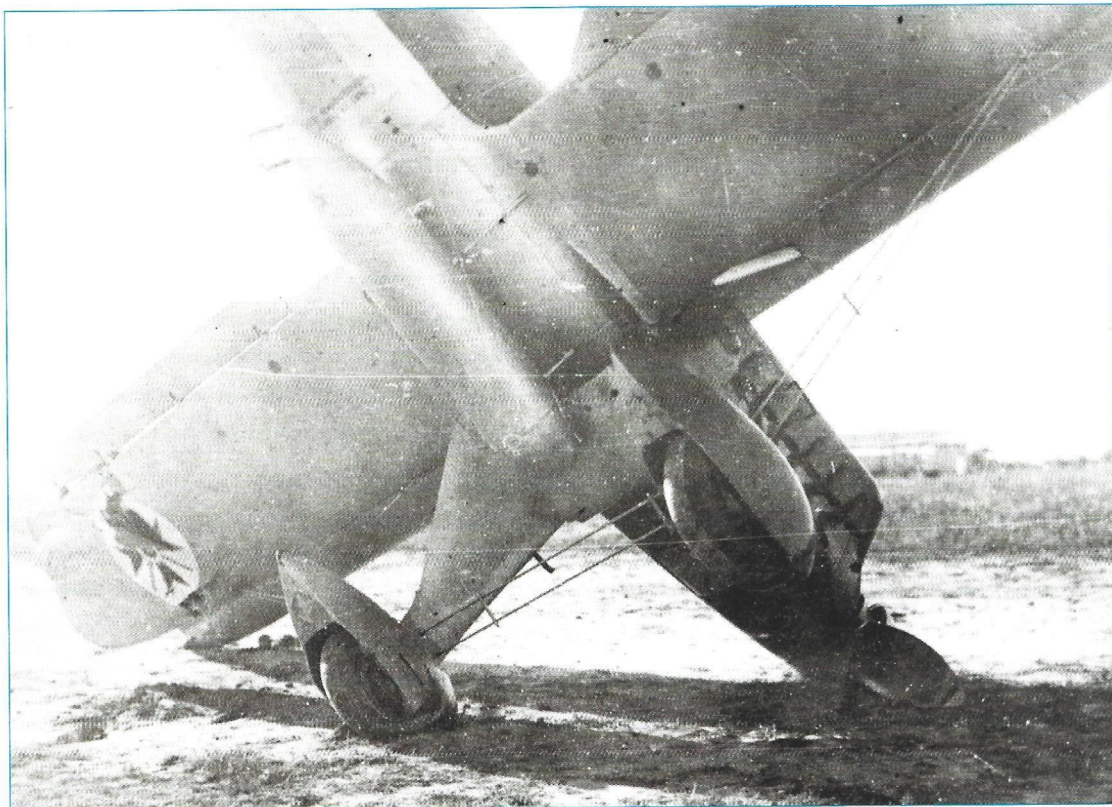
This unlucky He 51 ended up on its nose while taxiing on soft ground. Such minor accidents were usually repaired at unit level. This belly shot reveals details usually hidden from the camera, like the black service markings, in Bulgarian, stencilled on the mid-fuselage belly, in line with the step-on frame.

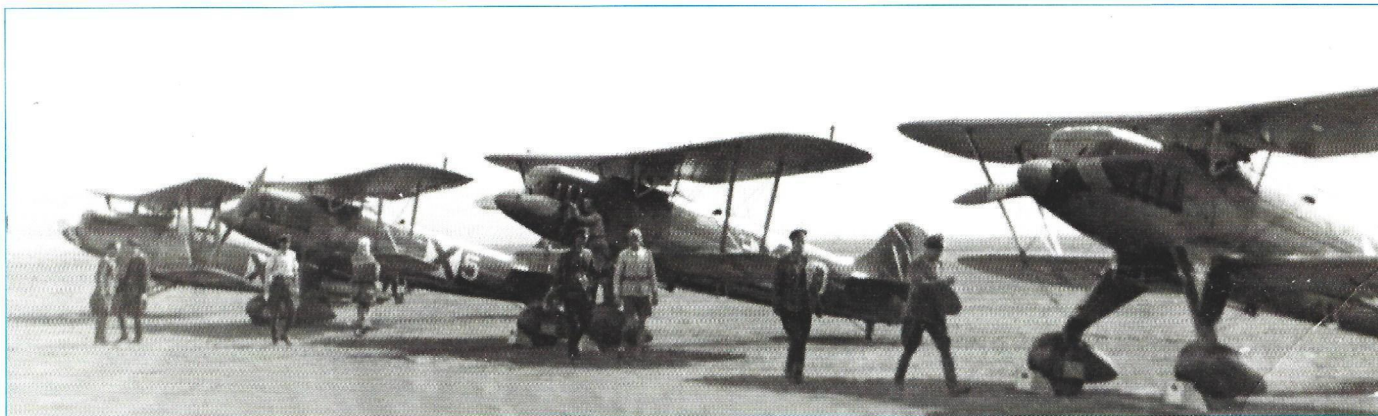
By the time of the marking change, the He 51 was relegated to the secondary role of fighter trainer. Notice the stripe-painted propeller of the machine at right, in contrast to the other ones, which have the propeller blades in grey (including the Ar 65F at extreme left). All these aircraft wear yellow engine cowling and rearward tapering fuselage stripe.

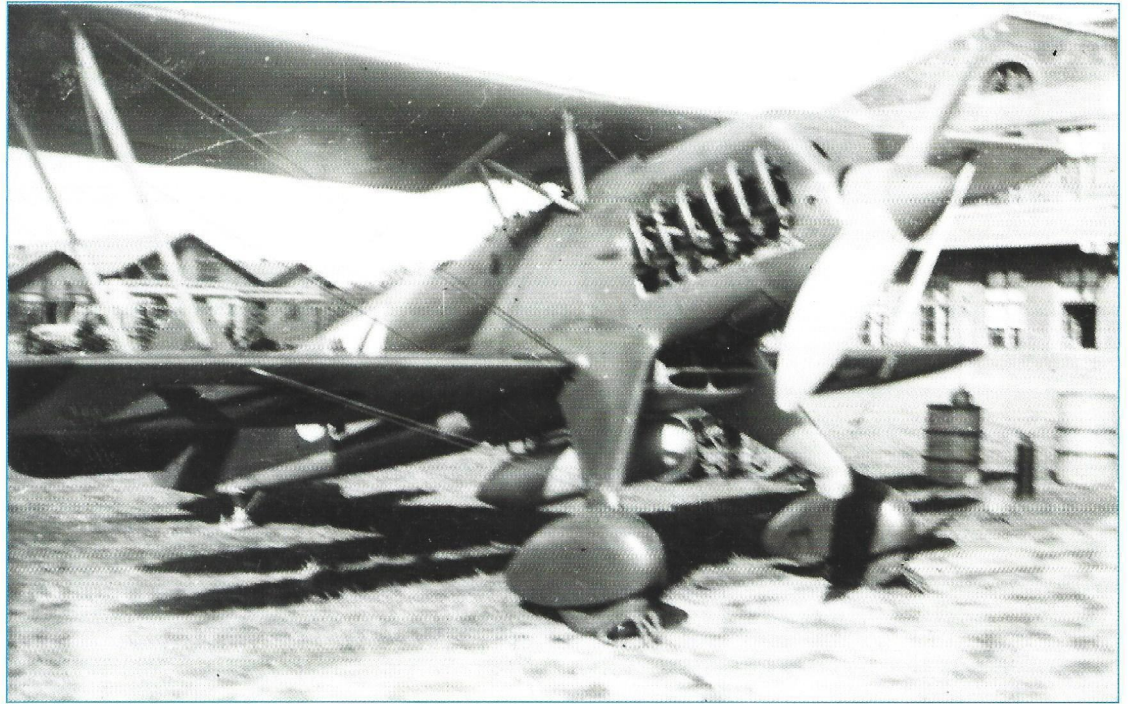
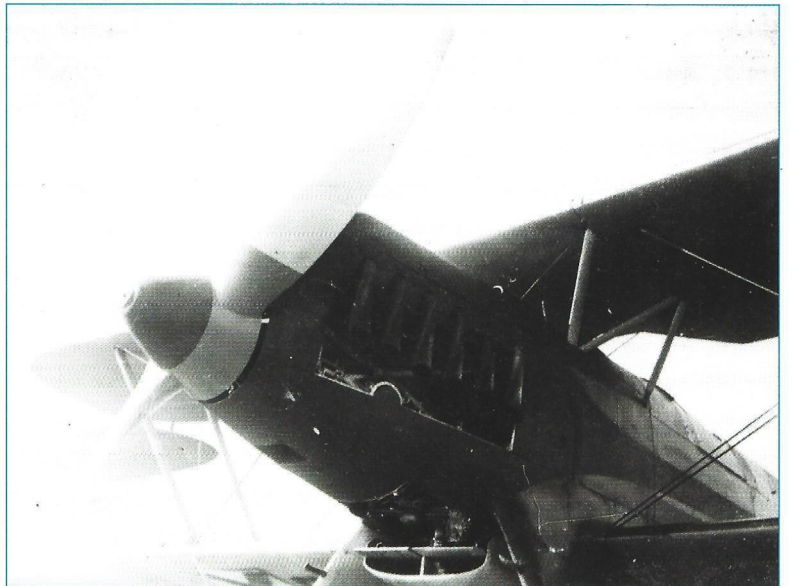
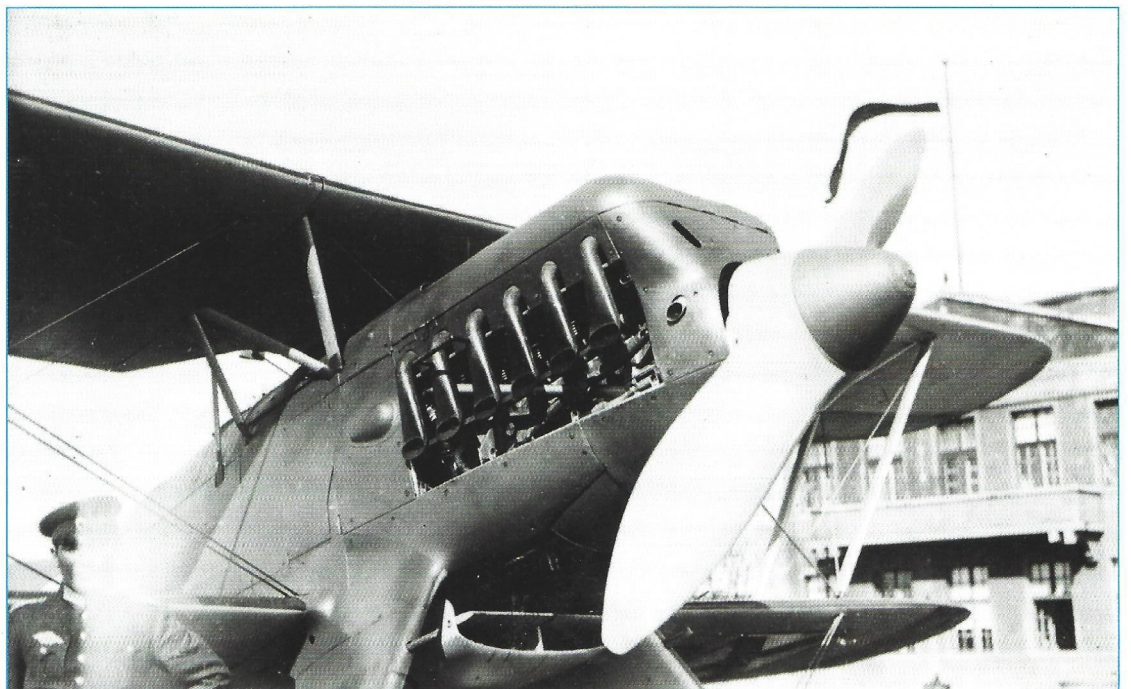
These three photos depict No. 8, parked on Bozhurishte airfield, sometime in 1943. Notice the yellow stripes on the lower wingtips.

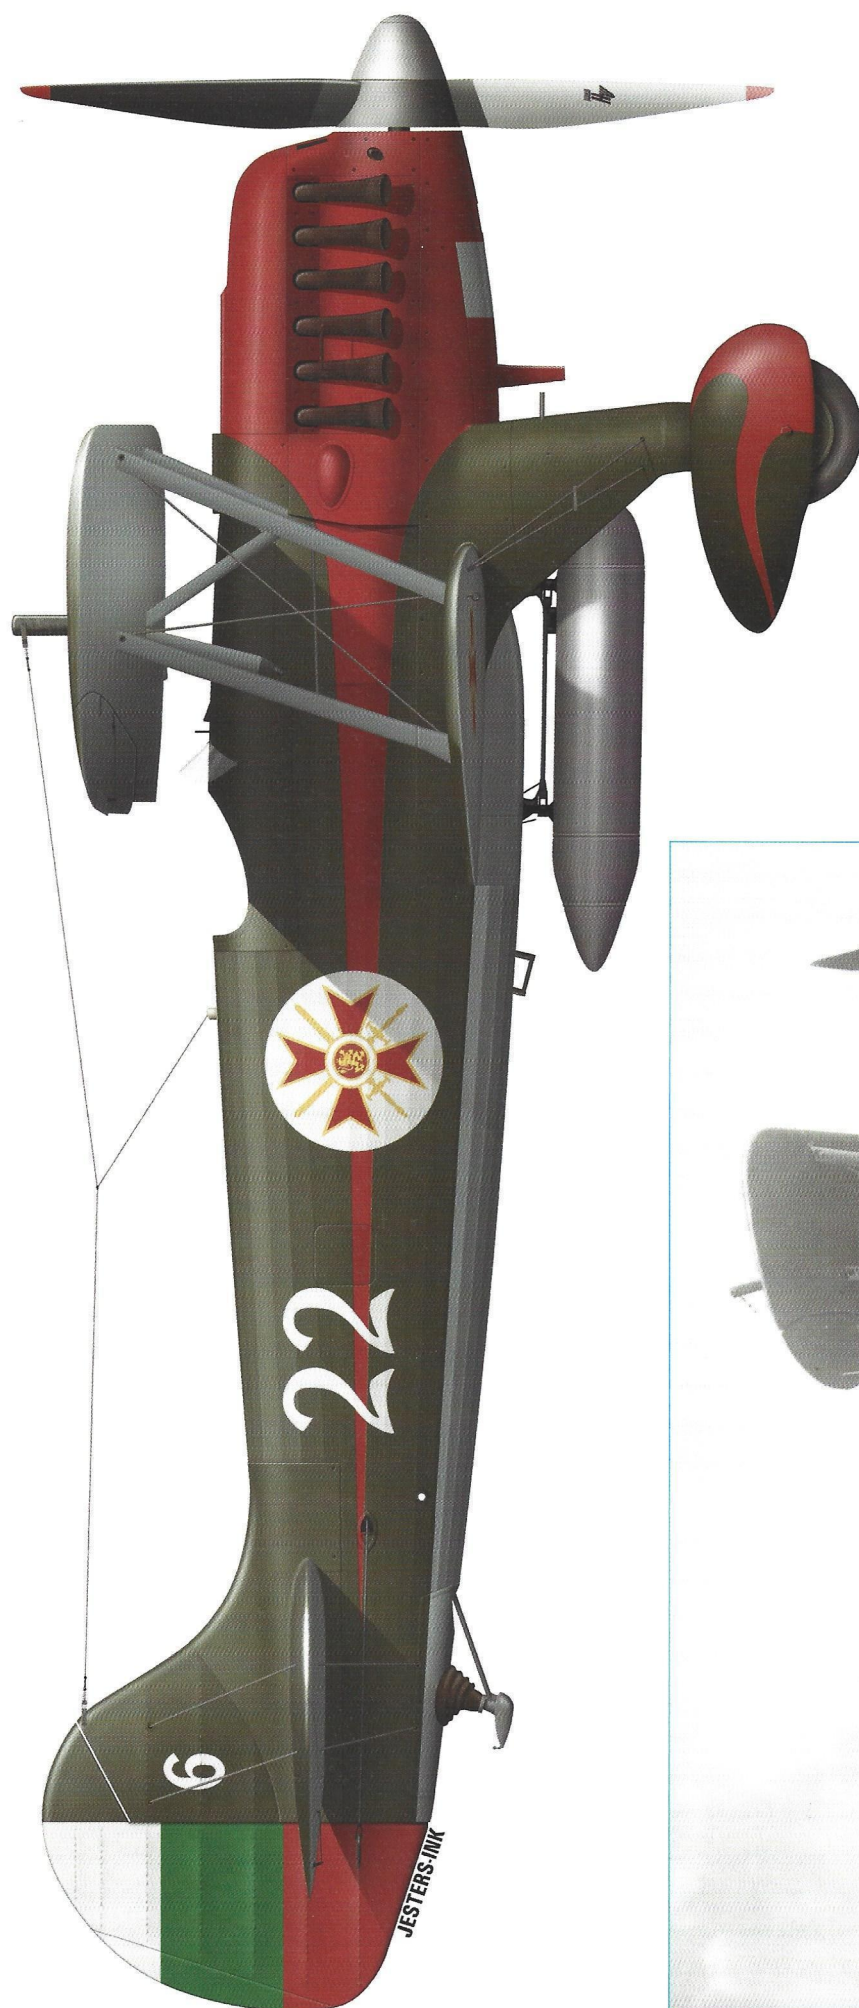
Heinkel He 51C Sokol, No. 22-6, pilot Kapitan Ivan S. Ivanov, Bozhurishite airfield, 6 May 1937. Camouflage colours: Dark Green over Light Blue. Wing struts also Light Blue. Engine cowling Red all around (except for the rectangular flash on the lower area, which stayed metal), extended rearwards by a tapered horizontal flash along the fuselage. Artwork on the wheel spats also in Red. White-Green-Red rudder. Outside surface of propeller blades Grey, inside dull Black, tips Red. Decal with the Heinkel factory logo on the outer propeller blade surface. Early style VNVV military marking in six positions. Serial numbers White. Auxiliary underbelly fuel tank in shiny natural metal.

Once the He 51s were officially taken over by the Bulgarian air force in early 1937, they received full VNVV military markings and identification numbers, as depicted in this superb profile view of No. 22-6. The engine cowling was painted in Red all around, extended by a tapered horizontal flash along the fuselage that ended underneath the tail plane. Additional artwork, representing stylised hawk's claws, was painted on the wheel spats, also in Red. Undoubtedly, the Bulgarian Heinkel He 51s featured a very vivid, eye catching colour scheme.

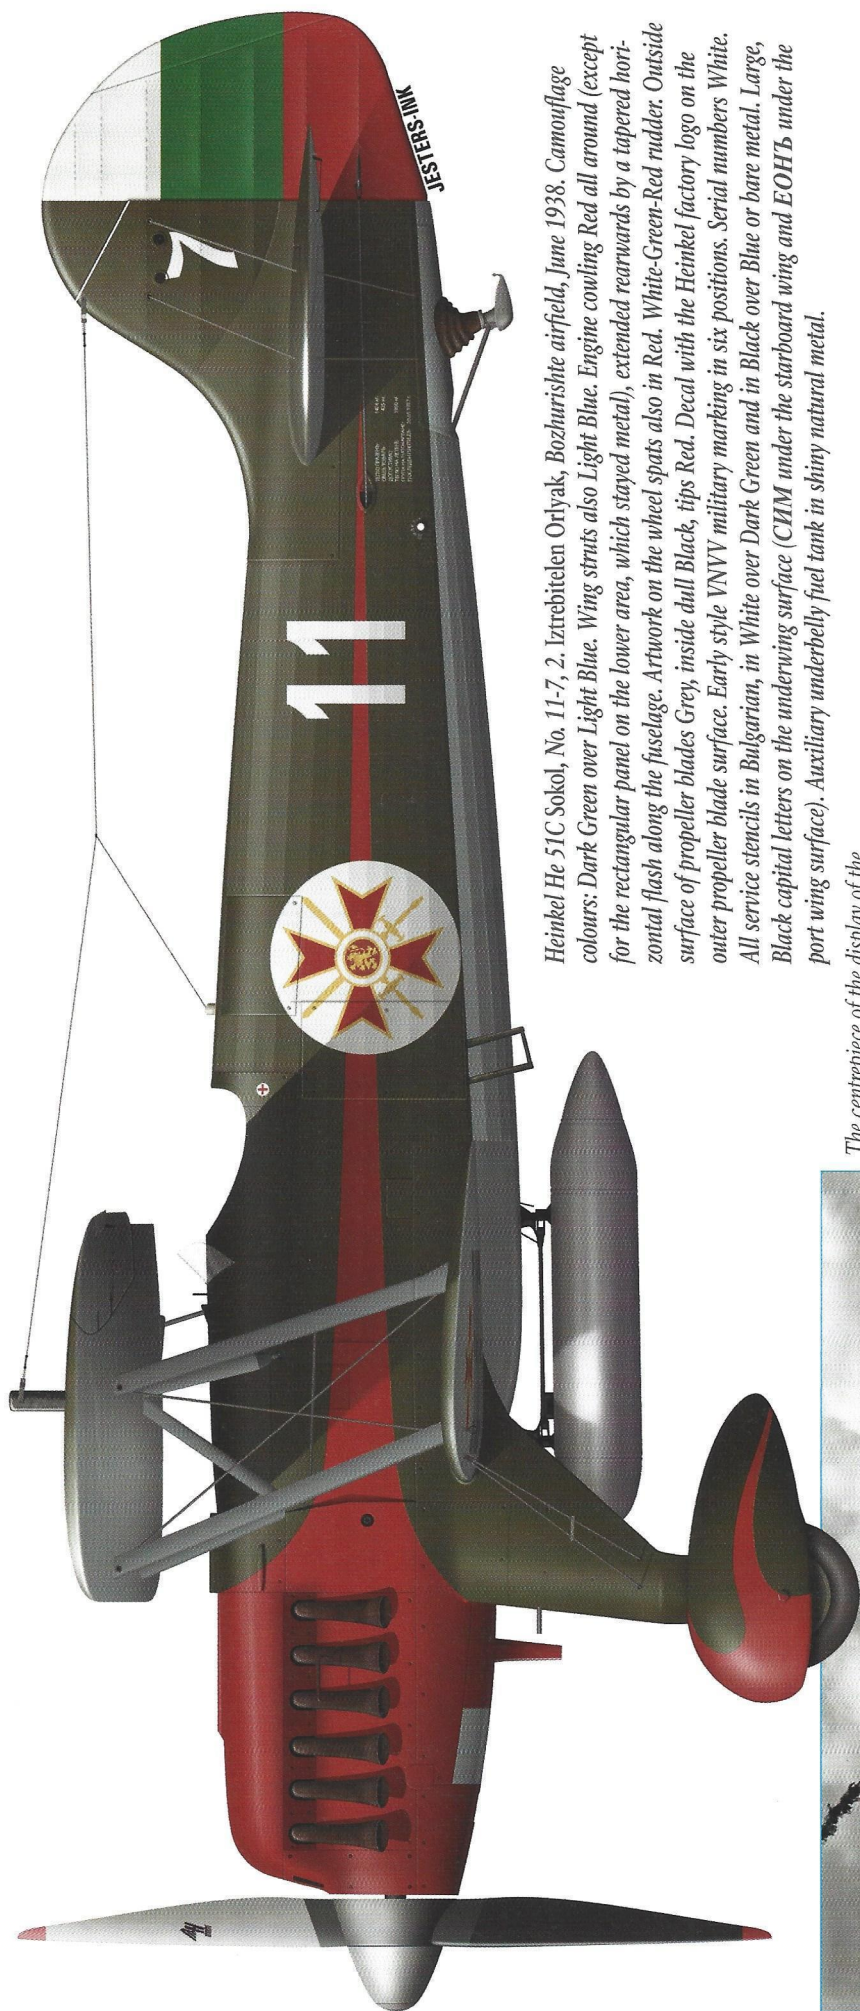
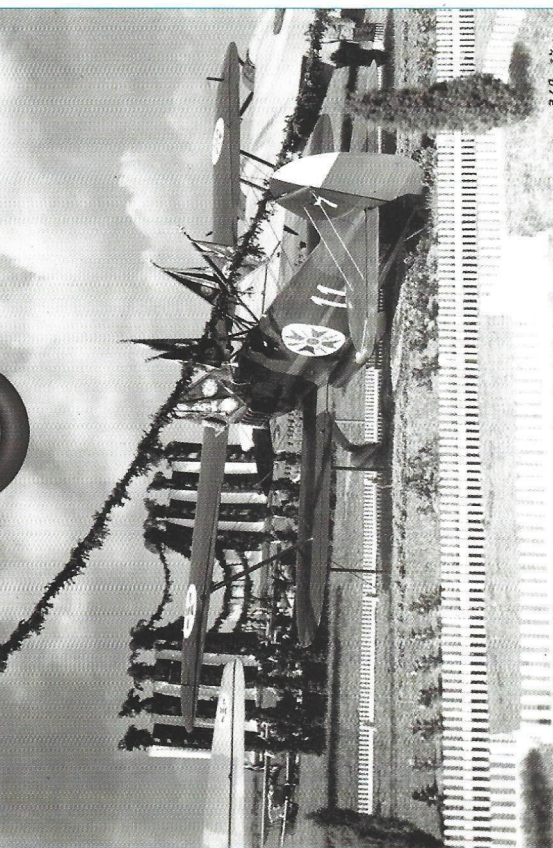
Heinkel He 51C Sokol, No. 11-7, 2. Iztrebitelen Orlyak, Bozhurishite Orlyak, June 1938. Camouflage colours: Dark Green over Light Blue. Wing struts also Light Blue. Engine cowling Red all around (except for the rectangular panel on the lower area, which stayed metal), extended rearwards by a tapered horizontal flash along the fuselage. Artwork on the wheel spats also in Red. White-Green-Red rudder. Outside surface of propeller blades Grey, inside dull Black, tips Red. Decal with the Heinkel factory logo on the outer propeller blade surface. Early style VNVV military marking in six positions. Serial numbers White. All service stencils in Bulgarian, in White over Dark Green and in Black over Blue or bare metal. Large, Black capital letters on the underwing surface (СИМ under the starboard wing and ЕОНЪ under the port wing surface). Auxiliary underbelly fuel tank in shiny natural metal.

The centrepiece of the display of the newly acquired German warplanes presented to Tsar Boris III at Bozhurishite main air base on 27 June 1937 was He 51C, No. 11-7. Note how significant is the colour shade difference of the Dark Green when painted on a metal surface (the piece in front of the fin) and on fabric. Also, the shades of mid-Green and blood Red painted on the rudder look identical on this photograph. The aircraft sported on its lower wing under surface the name of Tsar Boris' new-born son, Simoon, in large, black capital letters (СИМ under the starboard wing and ЕОНЪ under the port wing surface).

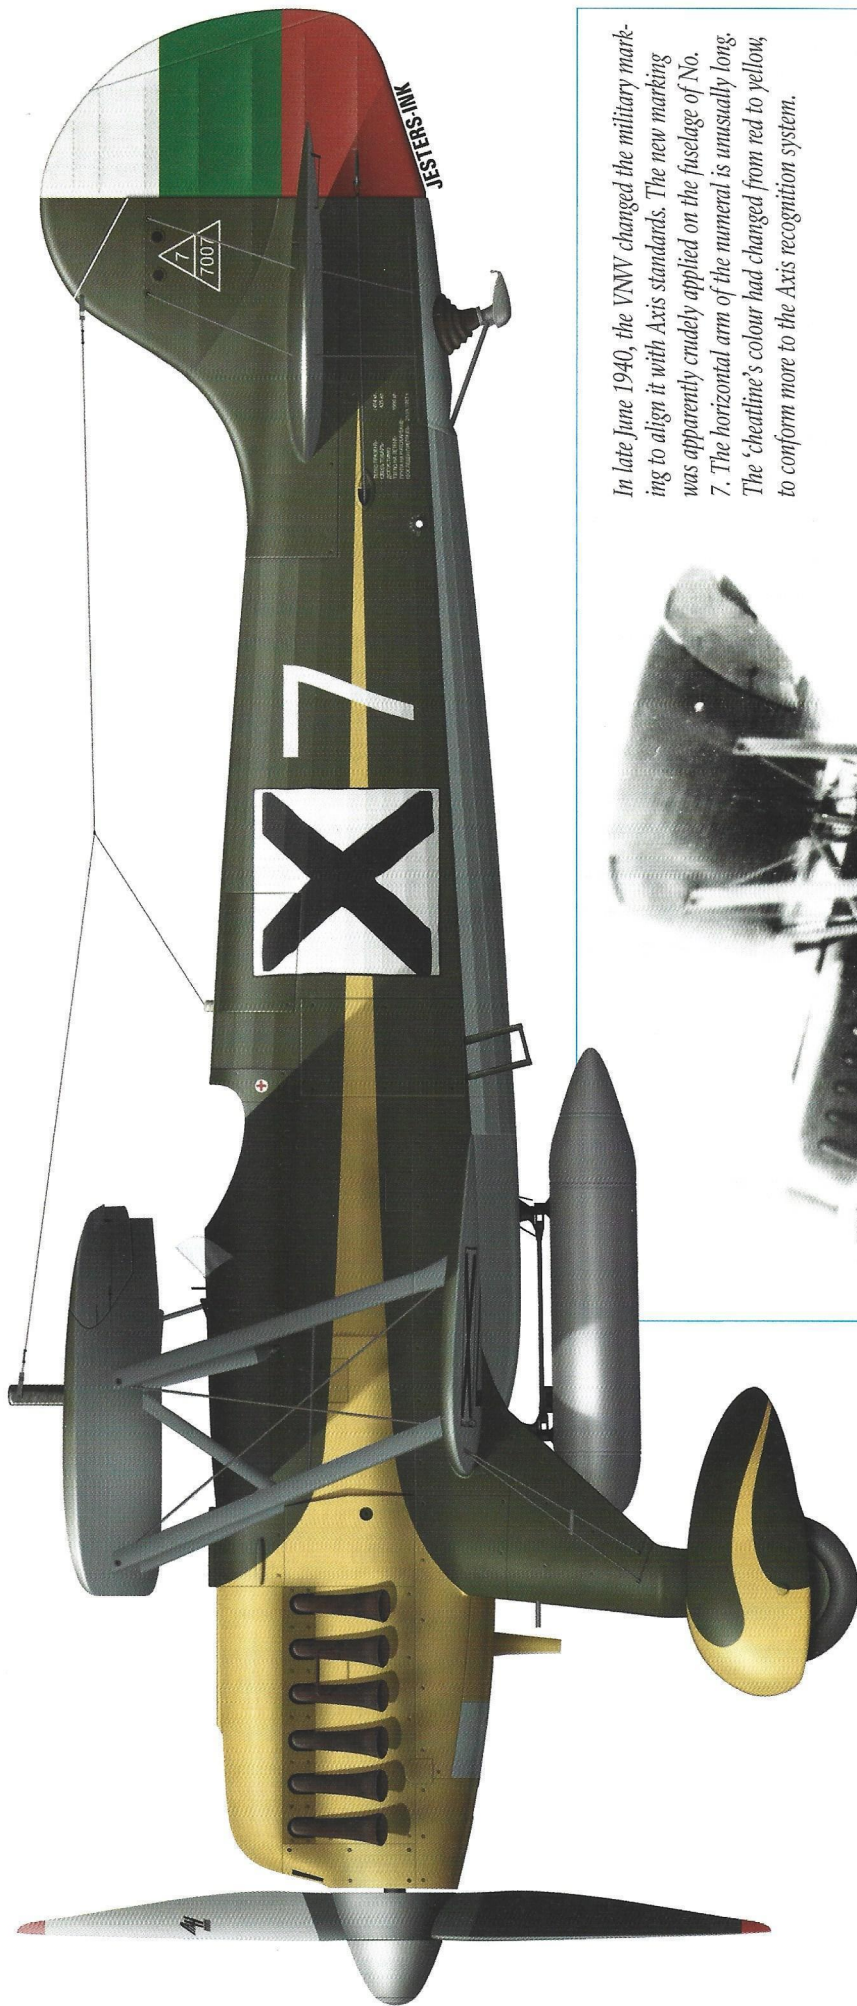
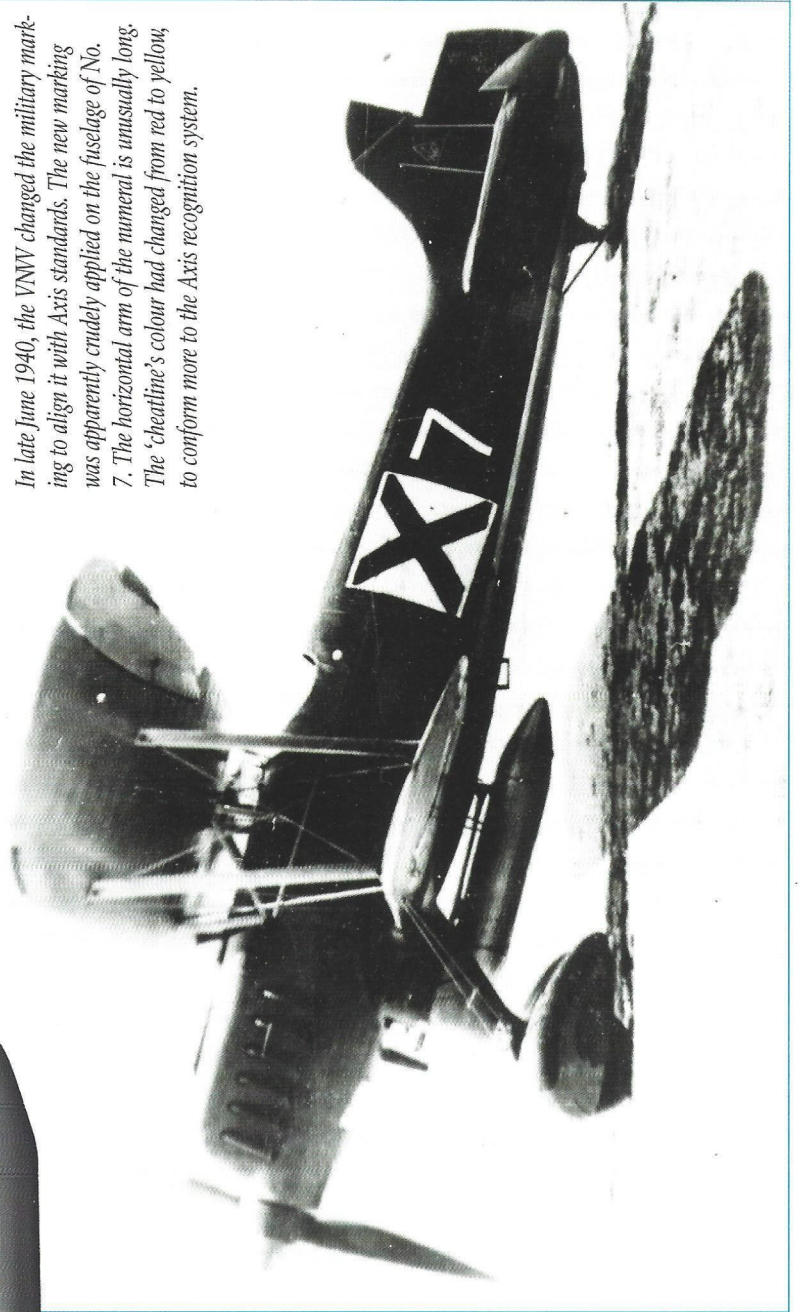
Heinkel He 51C Sokol, No. 7, Shkola za vissh pilotazh, pilot Poruchik Chudomir M. Toplodolski, Karlovo airfield, late 1941. Camouflage colours: Dark Green over Light Blue. Wing struts also Light Blue. Engine cowling Yellow all around (except for the rectangular panel on the lower area, which stayed metal), extended rearwards by a tapered horizontal flash along the fuselage. Artwork on the wheel spats also in Yellow. White-Green-Red rudder. Outside surface of propeller blades Grey, inside dull Black, tips Red. Decal with the Heinkel factory logo on the outer propeller blade surface. Axis style VNVV military marking in six positions, crudely applied onto the airframe. Serial number on fuselage in White, Black on wing under surface (inside of the marking). Triangle on fin White. All service stencils in Bulgarian, in White over Dark Green and in Black over Light Blue or metal. Auxiliary underbelly fuel tank in shiny natural metal.

In late June 1940, the VNVV changed the military marking to align it with Axis standards. The new marking was apparently crudely applied on the fuselage of No. 7. The horizontal arm of the numeral is unusually long. The 'cheatline's colour had changed from red to yellow, to conform more to the Axis recognition system.

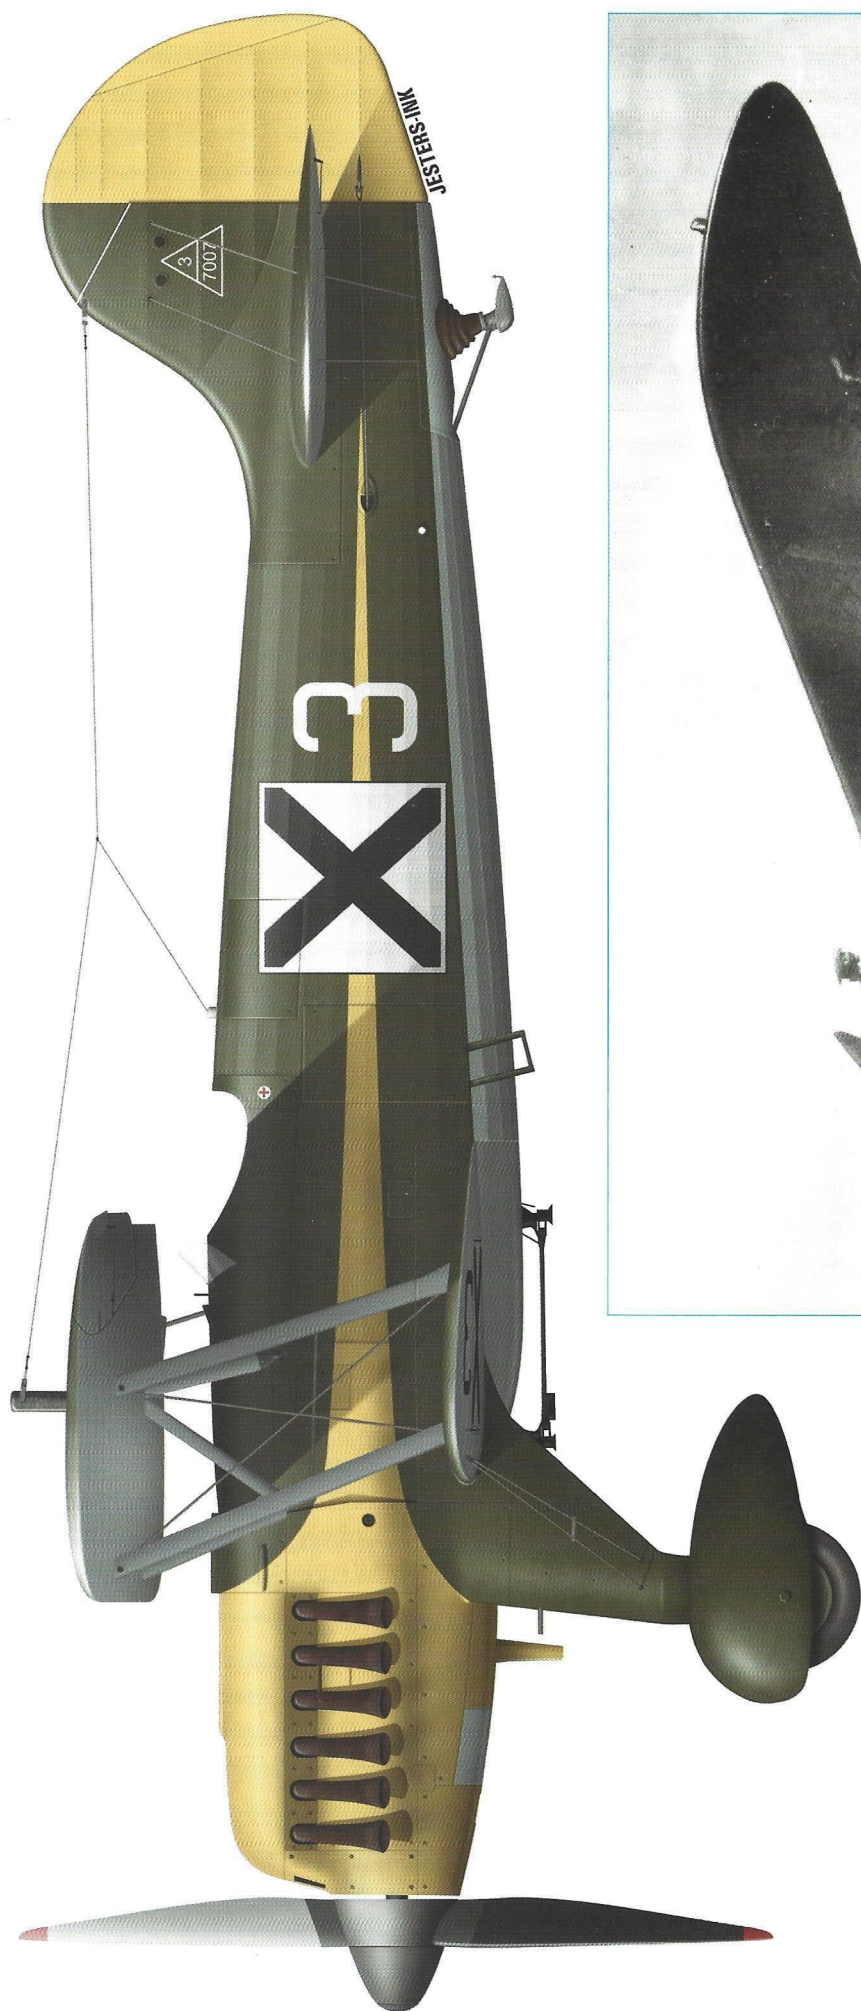
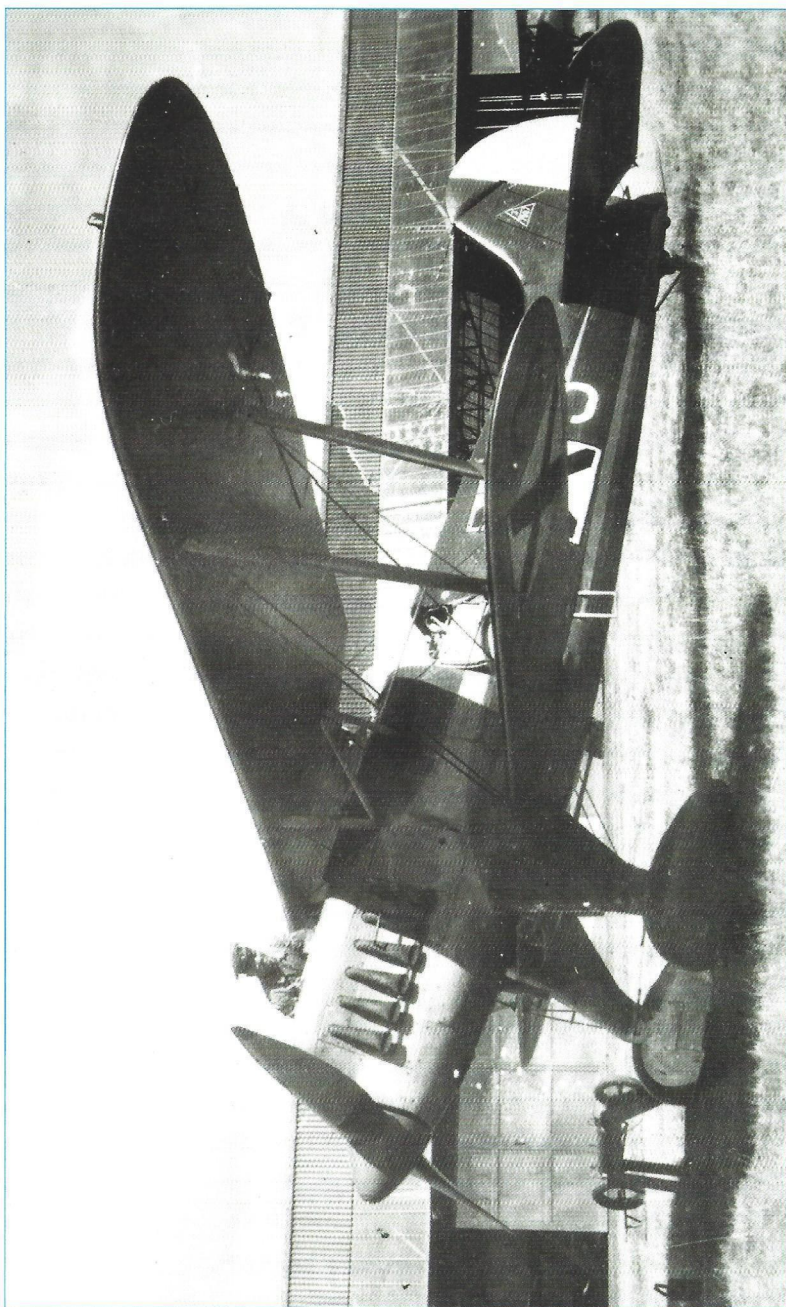
Heinkel He 51C Sokol, No. 3, Shkola za Iztrebiteli, pilot Podporuchnik Petăr D. Manolev, Dolna Mitropoliya airfield, June 1942. Camouflage colours: Dark Green over Light Blue. Wing struts also Light Blue. Engine cowling Yellow all around (except for the rectangular panel on the lower area, which stayed metal), extended rearwards by a tapered horizontal flash along the fuselage. Yellow rudder. Outside surface of propeller blades Grey, inside dull Black, tips Red. Axis style VNVV marking in six positions. Serial numbers on fuselage in White, Black on wing under surface (outside of the marking). Triangle on fin White.

Following the invasion of Yugoslavia by the German Wehrmacht in April 1941, Bulgarian warplanes displayed even more 'Axis' yellow on the airframe. Accordingly, the Bulgarian national colours on the rudder were overpainted with yellow. Later, the lower wingtips were painted yellow as well. No. 3 was the second to last survivor, being officially scrapped on 12 November 1945.
